MANHATTAN BRIDGE REHABILITATION

Steel Is the
East River Workhorse

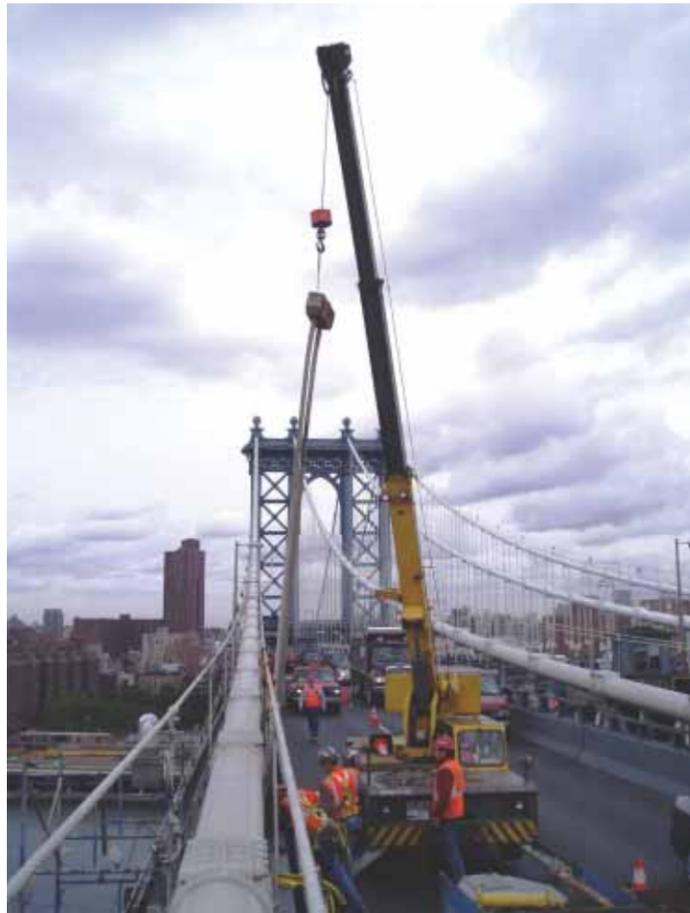
Previous 80,000 vehicles and 320,000 transit riders cross the Manhattan Bridge every day.

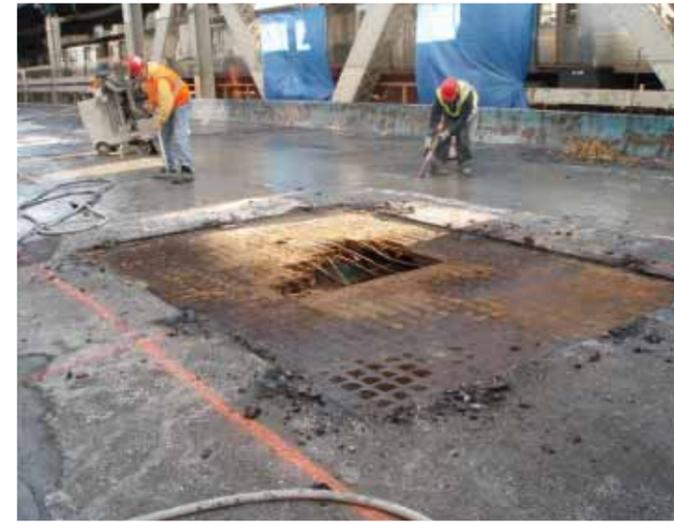
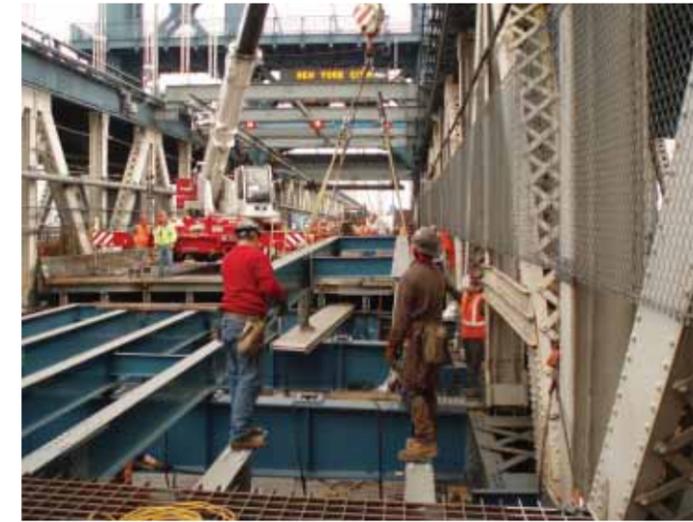
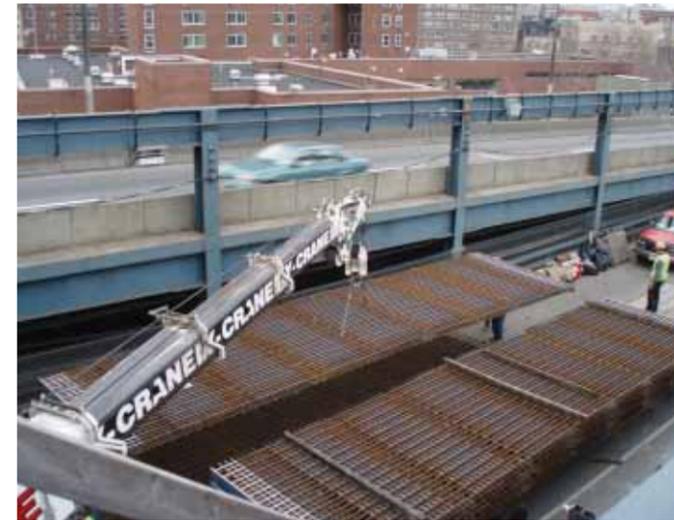
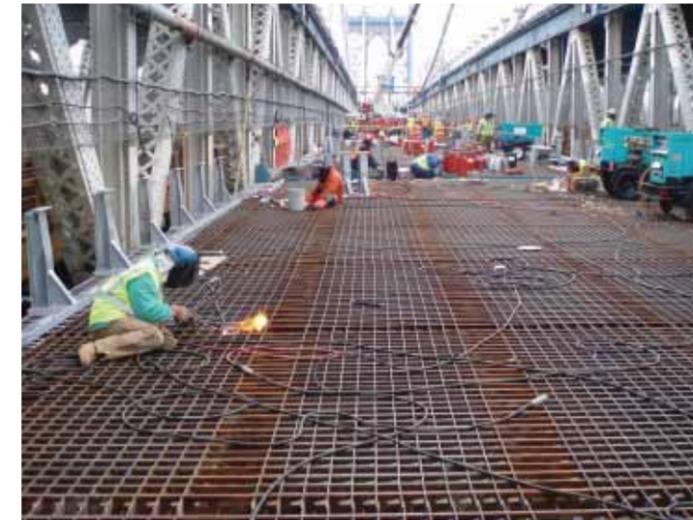
Above The bridge's suspender cables were replaced.
Facing The rehab replaced the span's floor beams and decking.

The torque tube plays the vital role in minimizing deflection. Weidlinger reinforced the lower lateral bracing, located beneath the bridge's lower deck, and installed all-new lateral bracing underneath the upper deck (the original had been removed in the 1950s due to visible cracking), forming a four-sided shape that led to its "tube" designation. The engineers also added 16 end frames to the towers and anchorages in order to better transfer twisting load into vertical load. The new steel reinforcing and bracing members are attached to the trusses via new, larger gusset plates, which vary in size depending on the forces present at the connection, but are never less than ¾ inch in thickness.

Although slightly different in appearance from the old lateral bracing, the new steel members are barely visible to drivers. All of the new lateral members are built-up T, reversed U, or H shapes, with the flanges welded to the stem. All connections are made using A325 high strength bolts. The cost of this phase of the work represented approximately 10 percent of the total budget. The larger proportion of project's steel contract was devoted to deck replacement. Divided into separate contracts, crews ultimately replaced approximately 1,600 roadway and subway track floor beams, and many more stringers. The existing roadway beams were built-up, riveted members, the ones replacing them are welded plate girders of the same size, but with improved section properties and stronger Grade 50 type steel. The new members are connected to the trusses with bolted connection angles using high strength bolts. But not all floor beams beneath the upper roadway were replaced, meaning that the bridge still hosts some older patch repairs made to counter section loss. Indeed, whole chunks of the structure had disappeared as a result of long exposure to

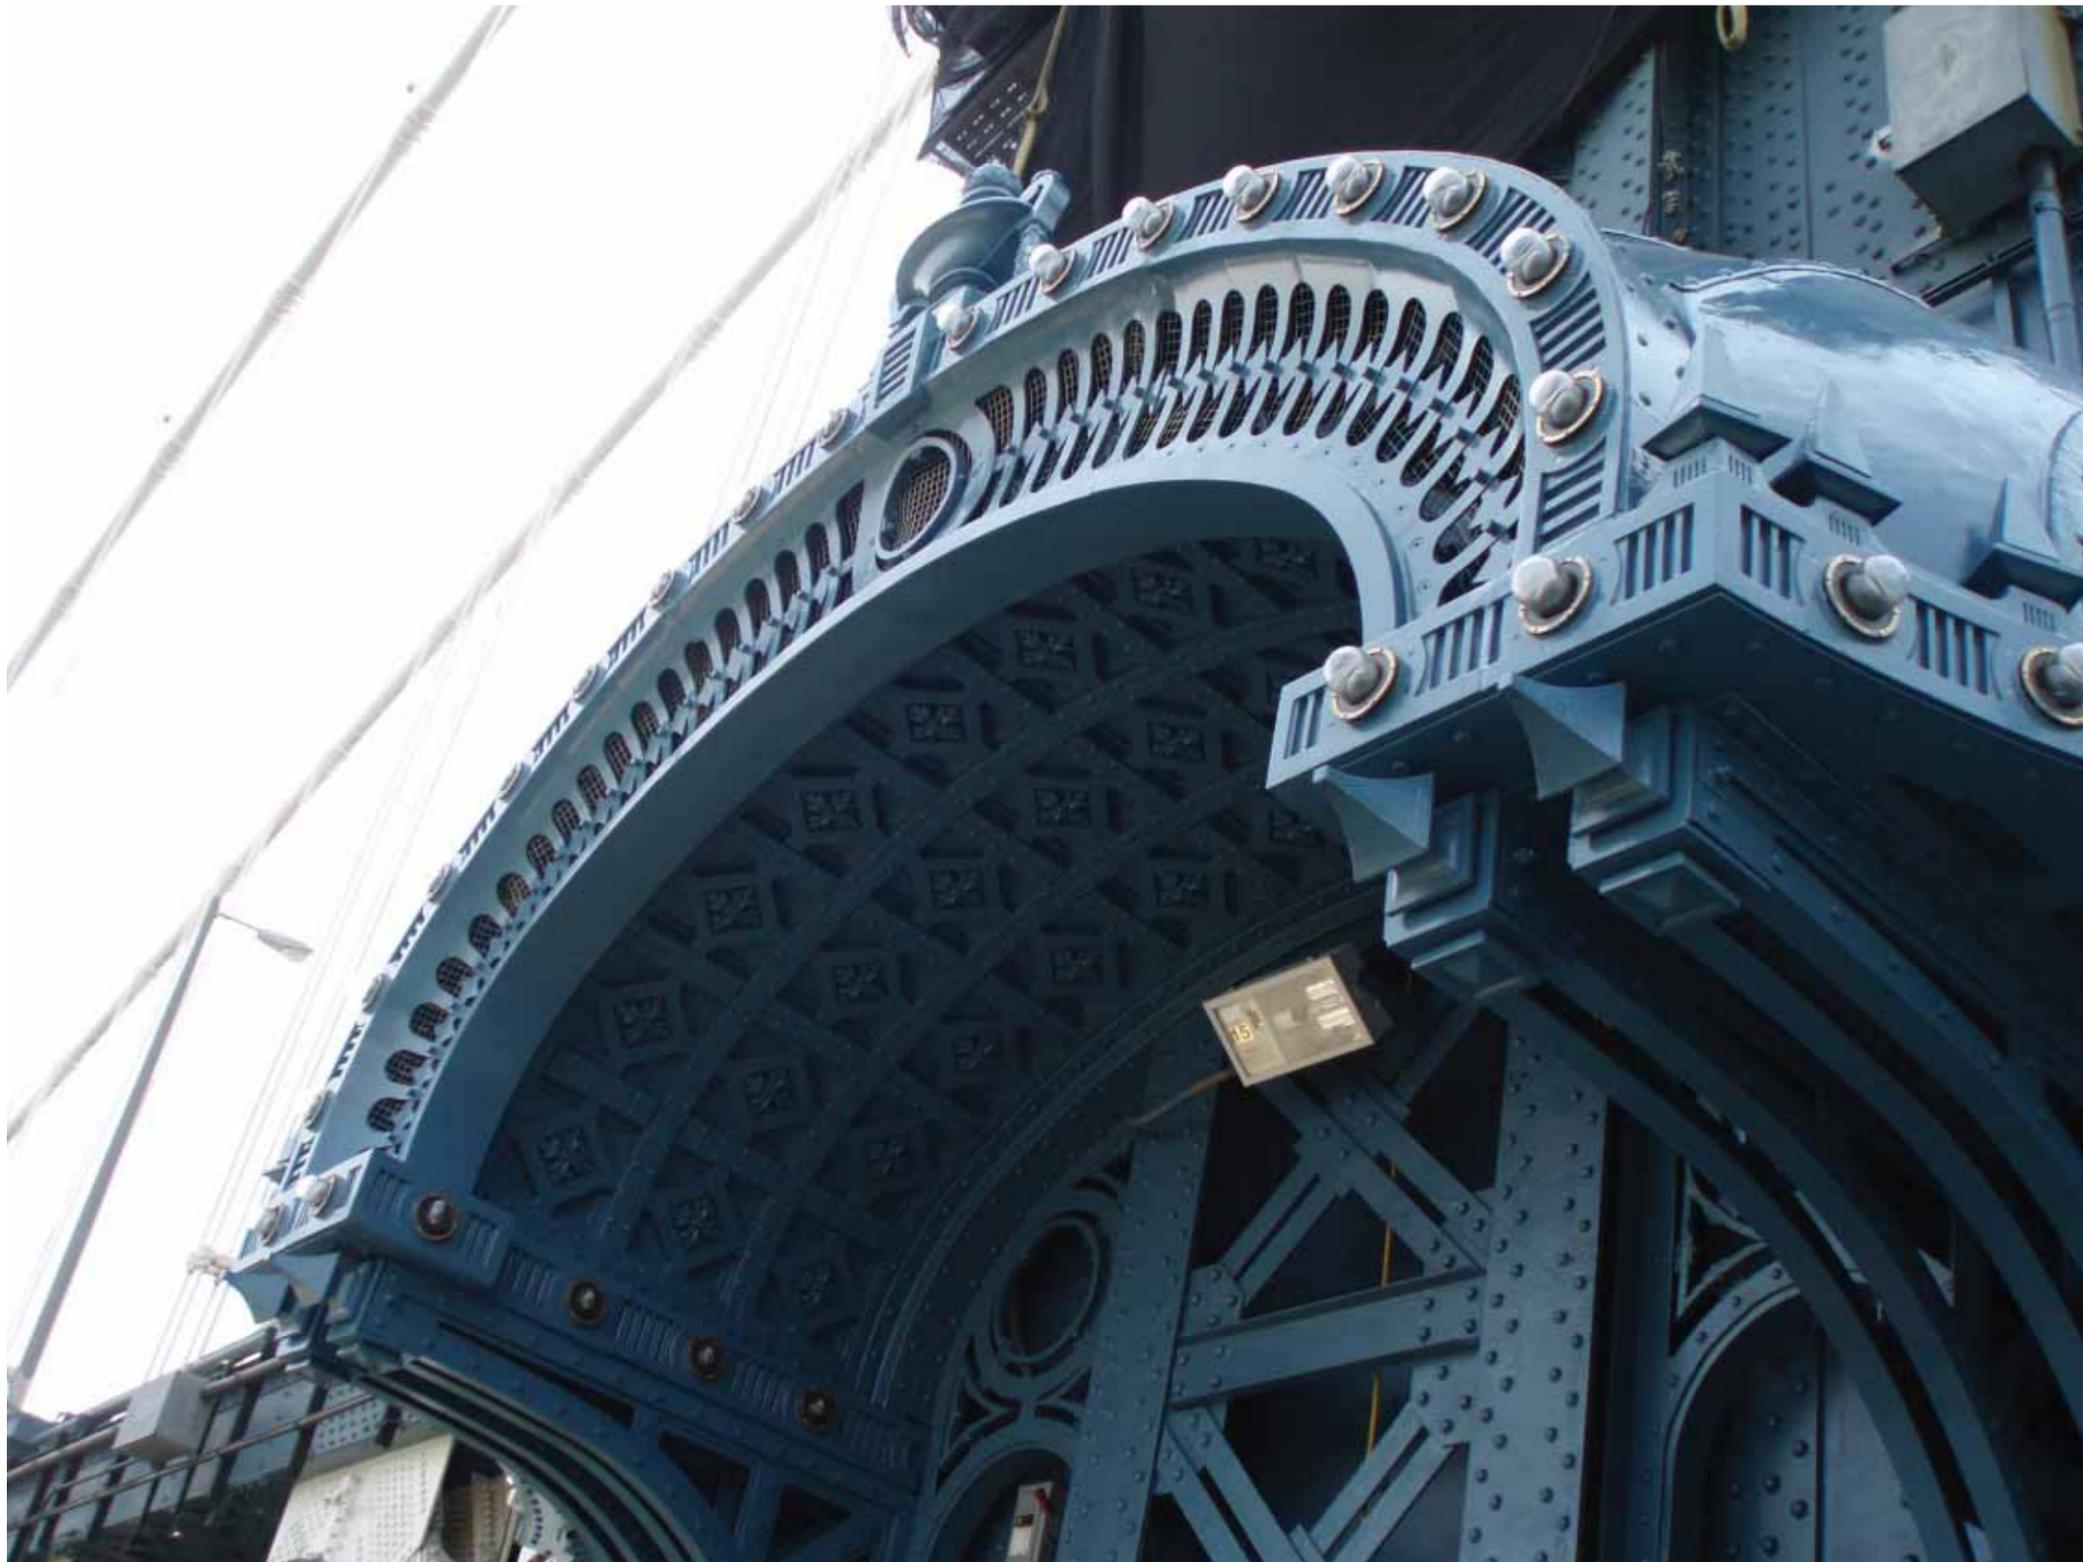
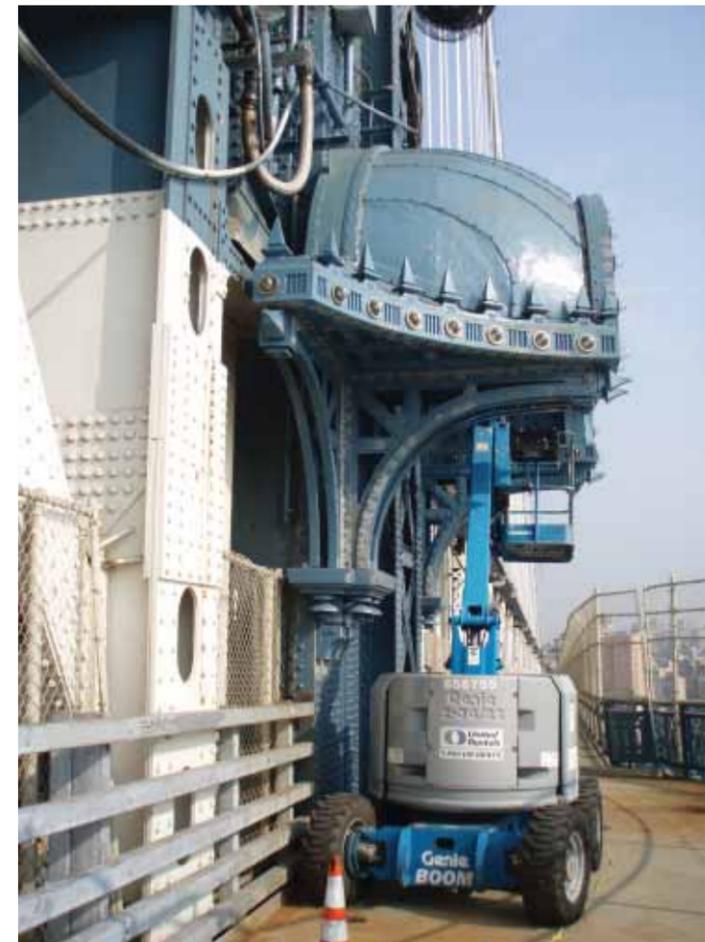
Facing and above Rehabilitation efforts included restoring the bridge's signature ornamental ironwork.

In the case of the bridge's signature decorative work, which includes canopy structures, handrails, and informational plaques, "we paid attention to the original architectural details that are evident and unique to the bridge," Terrence Daly, senior vice president of general contracting firm Koch Skanska and steel erector, says of the castings that were undertaken. "Some of that work is so unique for a contractor that it's difficult to price correctly. It's not something we do as a normal course of business."
